# Relative Performance Comparison Between Baseline Labyrinth and Dual-Brush Compressor Discharge Seals in a T-700 Engine Test

Prepared for the  
39th International Gas Turbine and Aeroengine Congress and Exposition  
sponsored by the American Society of Mechanical Engineers  
The Hague, Netherlands, June 13-16, 1994

1. AGENCY USE ONLY (Leave blank)	2. REPORT DATE October 1995	3. REPORT TYPE AND DATES COVERED Technical Memorandum		
4. TITLE AND SUBTITLE Relative Performance Comparison Between Baseline Labyrinth and Dual-Brush Compressor Discharge Seals in a T-700 Engine Test		5. FUNDING NUMBERS  WU-584-03-11 1L162211A47A

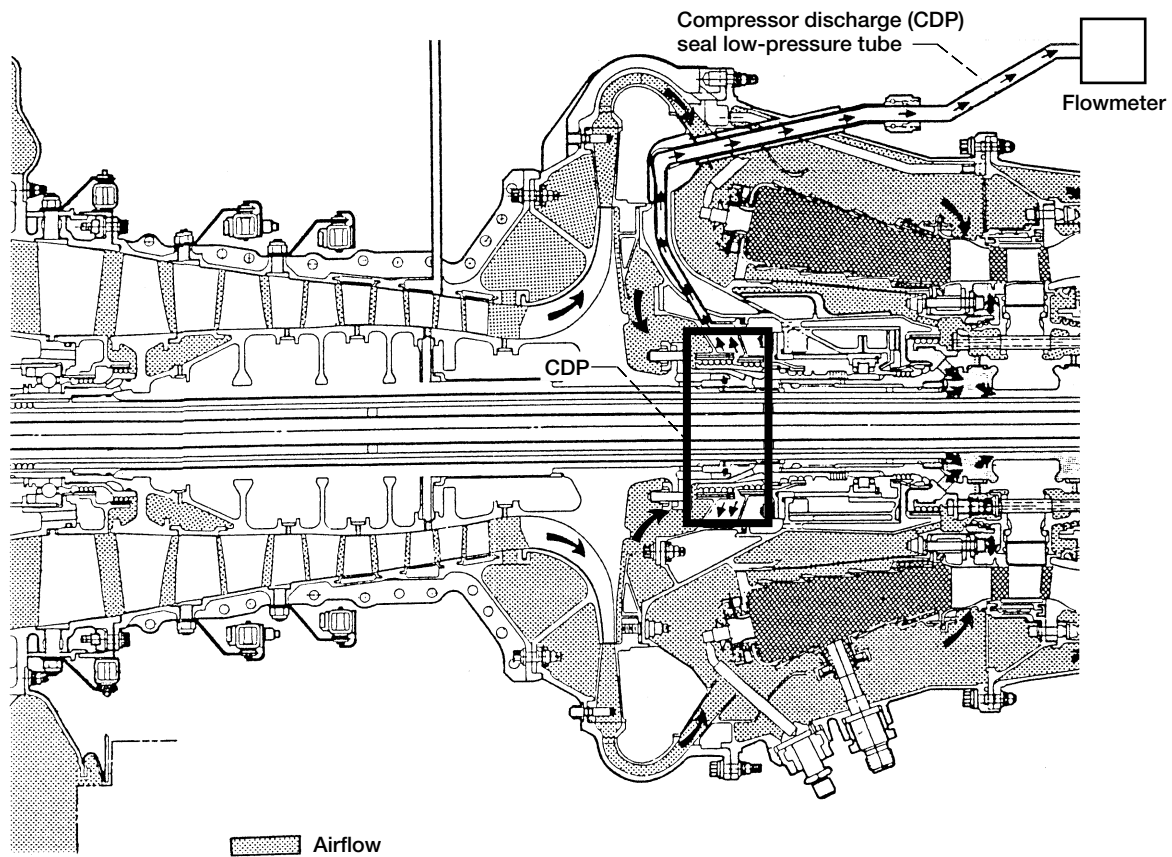
(a) Airflow schematic.

Figure 1.—Schematic of engine airflow and location of flowmeter.

The power stream airflow through the compressor and the secondary airflow leakage past the compressor discharge seal (CDP) are illustrated in Fig. 1(a), and the CDP viscous-tube flowmeter is shown in Fig. 1(b). The compressor discharge seal package and associated drain tube are located immediately downstream of the impeller and labeled CDS. The drain tube was opened after a series of runs and swabbed for debris.

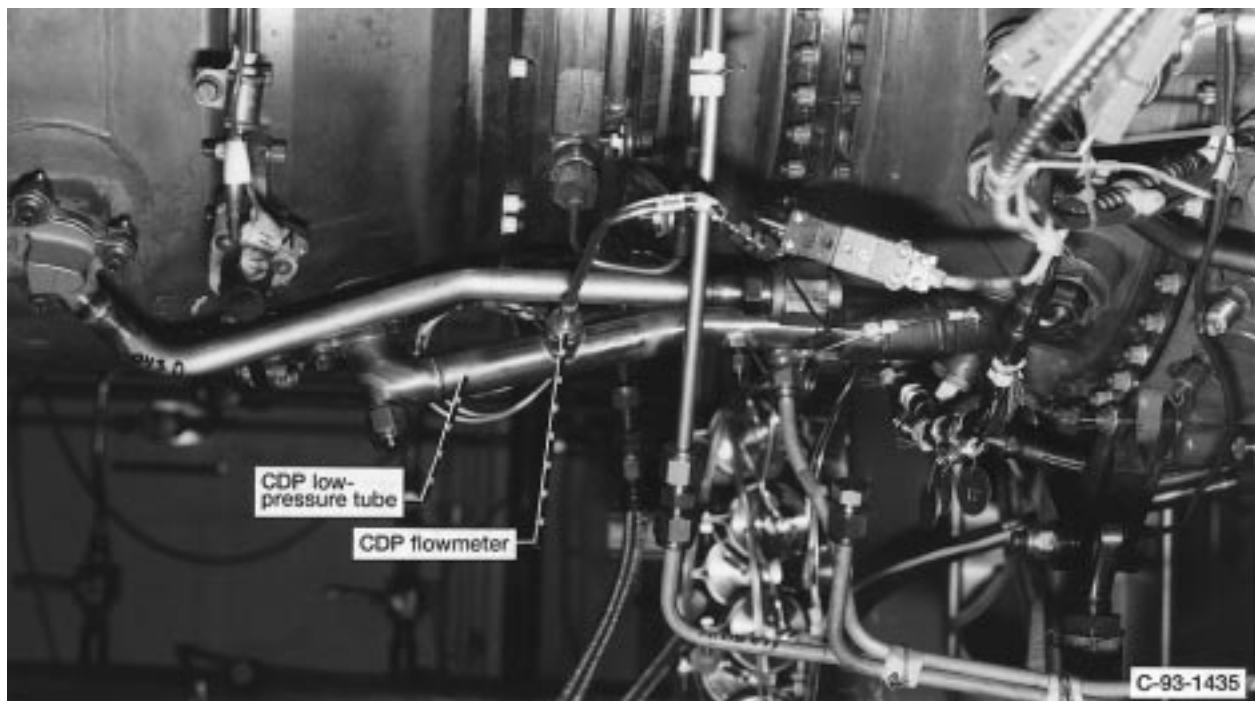
(b) Location of CDP flowmeter.

During the test series the drain pipe (Fig. 1) was swabbed for debris. When these samples were in turn investigated with a scanning electron microscope (SEM), nickel, chromium, and tungsten lines were observed along with other unexplainable peaks of salts (e.g., Fig. 12). The nickel, chromium, and tungsten lines characterize bristle materials and some possible coating wear. The debris was fine and difficult to locate and isolate within the tube. Other metal sources and rubbing surfaces could have also produced such debris, but we attributed it to bristle wear.

Representative seal leakage variations as a function of compressor discharge pressure are given as Fig. 14, with calculation parameters in Table I. (See Fig. 1(b) for the location of the flowmeter.) Readings 42 to 111 are labyrinth or baseline seal data; readings 331 to 342 are dual-brush seal data. On the average the labyrinth seal leakage is 2.5 times more than the dual-brush seal leakage and strongly depends on pressure relative to the dual brush. Increasing pressure tends to pack the dual-brush seal; leakage flow decreases to approximately 0.83 MPa (120 psi) and then increases. (It also stiffens the bristles and increases wear.) The pressure drops for each comparable compressor discharge pressure setting were higher for the brush seal system than for the labyrinth seal system (Tables I to III). For the same engine operating conditions the dual-brush system leaked less than the baseline forward-facing labyrinth seal system. Also implied is enhanced engine

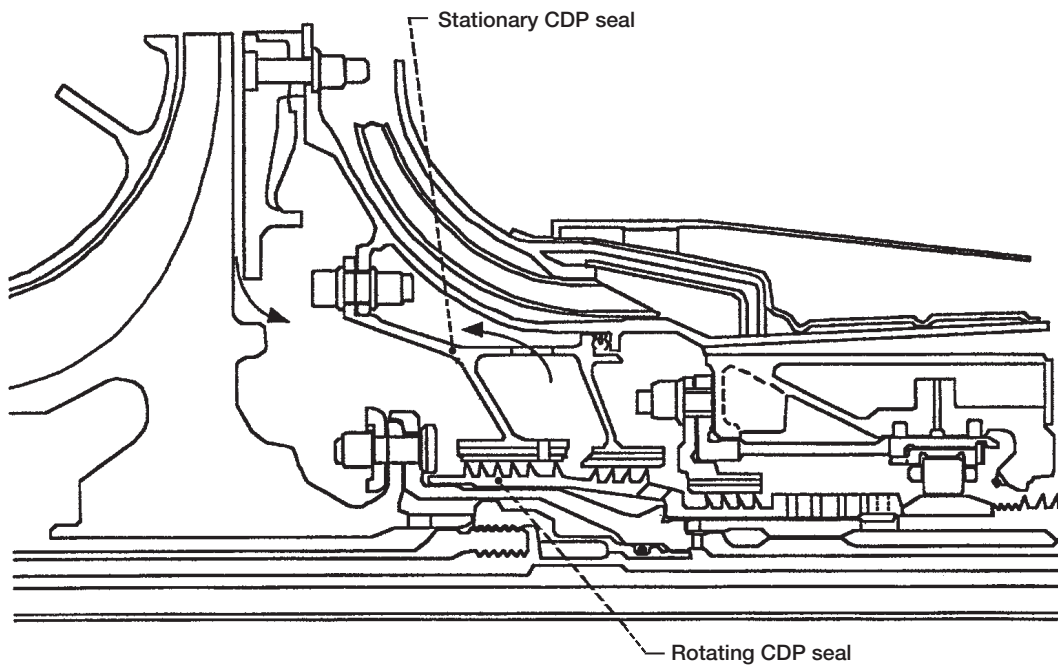
(a) Labyrinth seal package and airflow.

Figure 2.—Labyrinth compressor discharge seal system.

The labyrinth CDP seal package and airflow path are shown in Fig. 2(a). The nominal 71-mm (2.8-in.) diameter forward-facing labyrinth seal system is illustrated in Fig. 2(b). The labyrinth teeth rub into a felt-metal type of interface, forming the seal system. Note that the teeth are not all forward facing and are used in different ways to satisfy different engine operating requirements. A simulated exploded view of the seal system is given in Fig. 3 and clearly illustrates the forward-facing teeth of the rotor. However, the housing shown in the figure is for the brush seal.

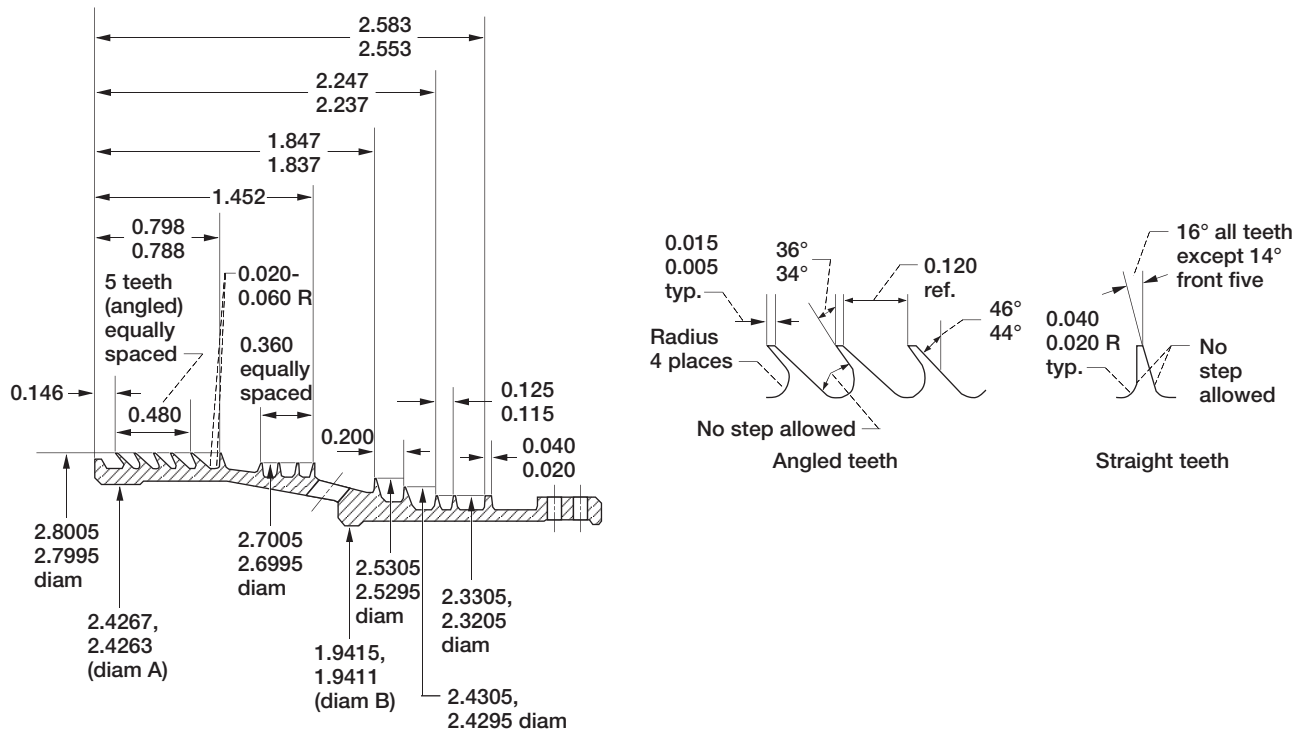
(b) Schematic of labyrinth compressor discharge seal. (Seal teeth and axis established by diameters A and B to be concentric within 0.003 full indicator reading. No steps allowed on tooth face or at fillet radius. All dimensions are in inches.)

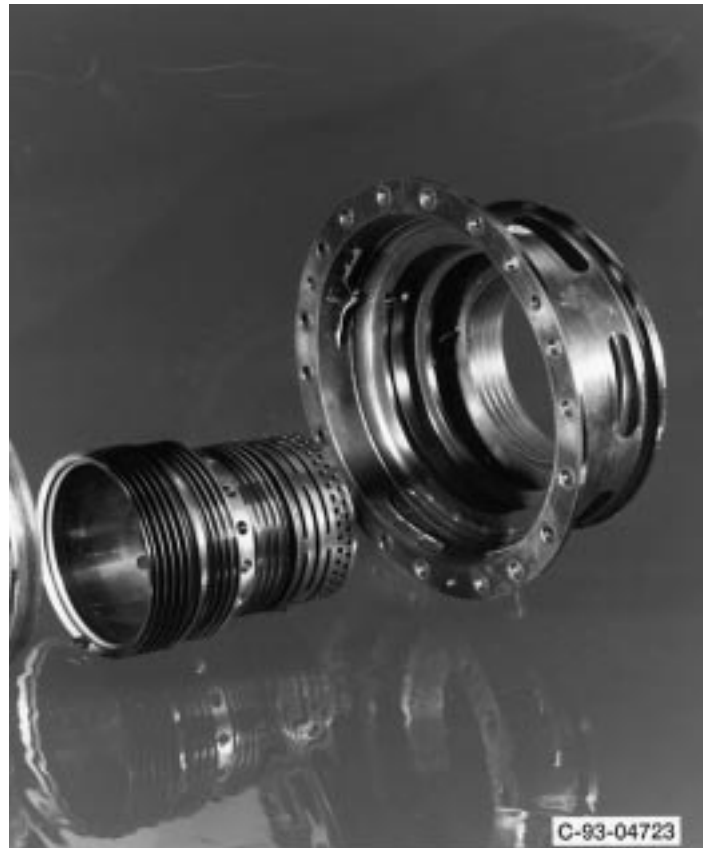
Figure 3.—Simulated exploded view of labyrinth compressor discharge seal system.

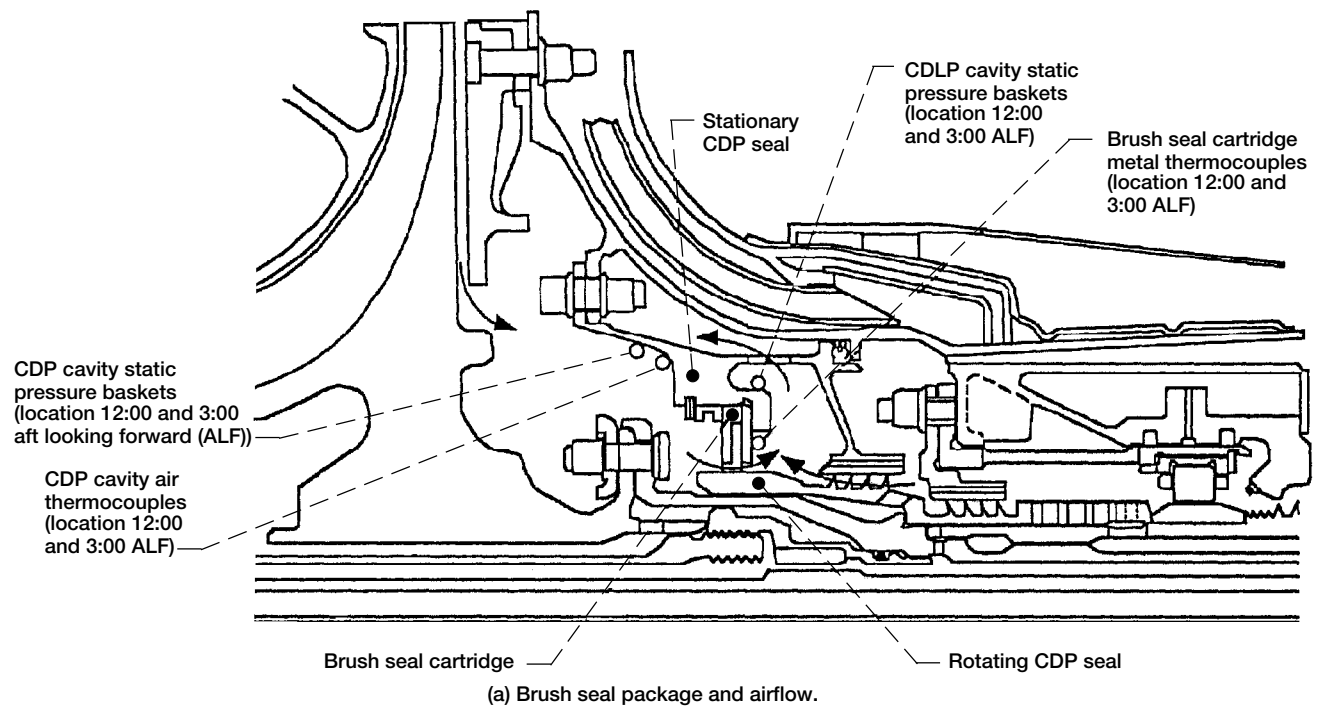
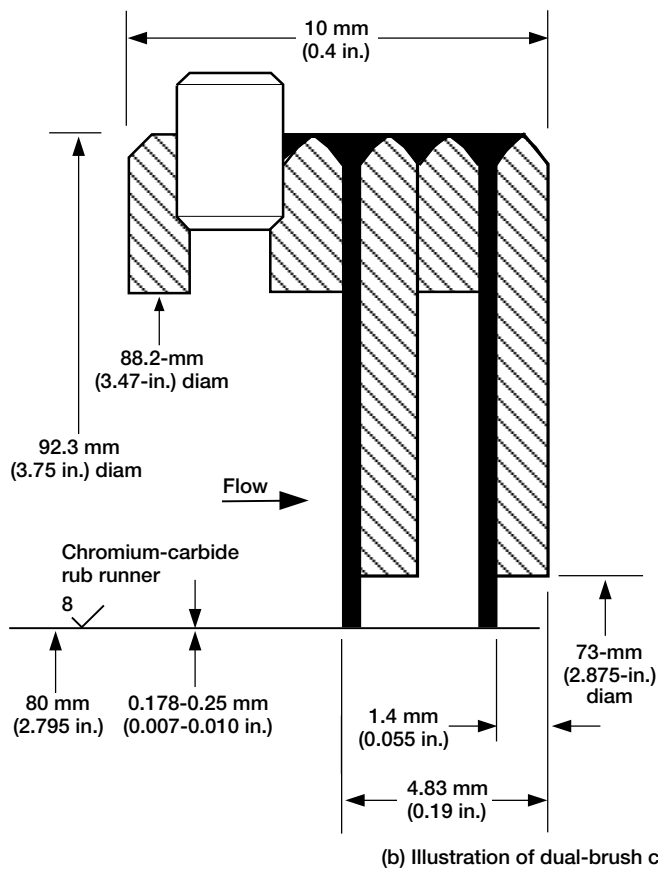
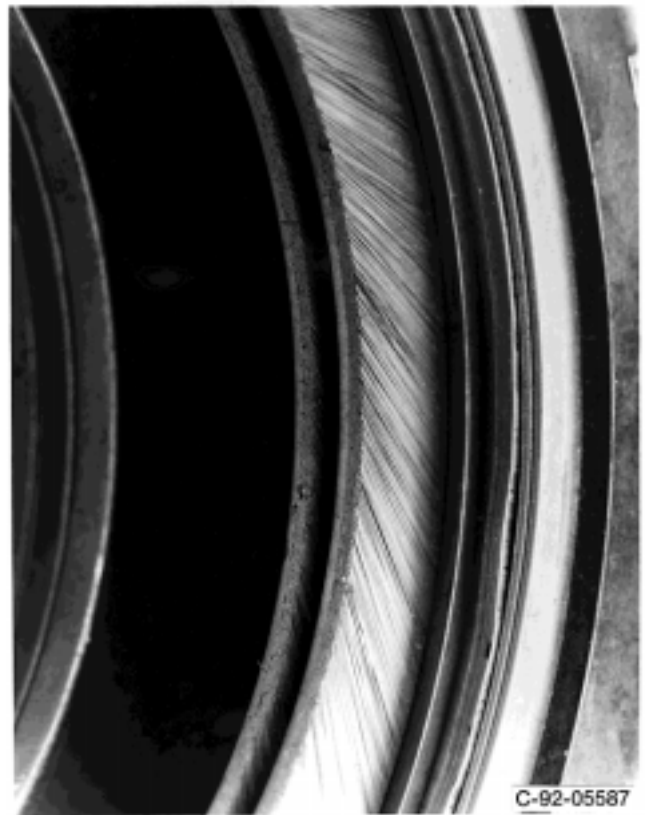
Figure 4.—Dual-brush compressor discharge seal system and schematic of airflow.

The dual brush was selected over a single brush for reliability of a critical engine component, distribution of the pressure drop per brush, and mitigation of wear. The dual-brush CDP seal package and airflow path are shown schematically in Fig. 4(a) and illustrated in Fig. 4(b). The dual brush, nominally 71 mm (2.8 in.) in diameter, runs against a 0.178- to 0.254-mm (0.007- to 0.010-in.) thick, smooth (8 rms) chromium-carbide-coated rub runner interface as shown schematically in Fig. 4(c). (See also Figs. 11(b) and (c) between wear scars.) The basic seal system was envisioned by General Electric and manufactured by Cross Mfg. Ltd. (Flower, 1990). It has 0.071-mm (0.0028-in.) diameter, Haynes 25 bristles angled 43° to 50° to the interface with approximately 98 to 99 per millimeter of circumference (2500 per inch of circumference) and a nominal interference fit of 0.127 mm (0.005 in.) at installation. Brush seal design conditions include surface speed of 168 m/s (550 ft/s), temperature of 740 K (870 °F), pressure drop of 0.6 MPa (84 psi), and bristle deflection of 0.64 mm (0.025 in.). Figure 5 gives a post-test exploded view of the brush seal system with associated instrumentation lines (cut after testing). Figure 6 provides a side-by-side comparison of the forward-facing labyrinth seal (right) and the chromium-carbide-coated rub runner replacement (left); these represent the rotating interface. This design could be enhanced by using an upstream "washer" to mitigate foreign object damage and by optimizing the backing washer thickness and profile to pressure loading to mitigate hysteresis.

Pretest and post-test photographs of the dual brush and its installation in the seal system are shown in Figs. 4, 5, and 7. Figure 4(b) depicts the dual brush prior to and Fig. 5 after testing. Figure 7(a) shows the upstream view of the instrumented housing; four thermocouples are attached to the side plates with upstream and downstream pressure taps. Figure 7(b) shows a direct view from the downstream side, and Fig. 7(c) is an isometric view showing the "shiny" nature of the bristle interface. Many seal dimensions and coating and installation details are proprietary.

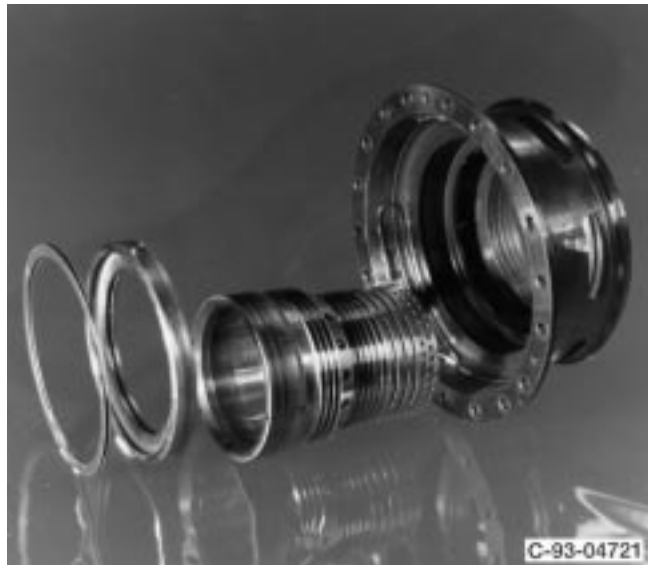
Figure 5.—Exploded view of dual-brush compressor discharge seal system (after test).

Another variation in the wear pattern is attributed to the rotor machining or coating variations (Fig. 11(a)). The rotor showed a small eccentricity and was investigated for metallic transfer, but no significant transfer was found. The chromium carbide interface was worn smoother by the rubbing brush bristle interface, implying some form of wear or material smearing without significant transfer of the chromium carbide (CrC is usually a plasma-sprayed mixture of  $\text{Cr}_3\text{C}_2$  and  $\text{Cr}_7\text{C}_3$  ground and polished to form the rub-runner surface). The CrC-coated rub runner exhibited slight wear scars but no spallation or coating degradation otherwise, as illustrated in Fig. 11(b); however, eccentric operations, startup, or a hard rub caused a deeper scar over about  $120^\circ$  of the rotor as shown in Fig. 11(c). These wear bands are readily visible in Fig. 6, where the upper band is associated with the upstream (high-pressure side) brush; see also Figs. 5 and 8.

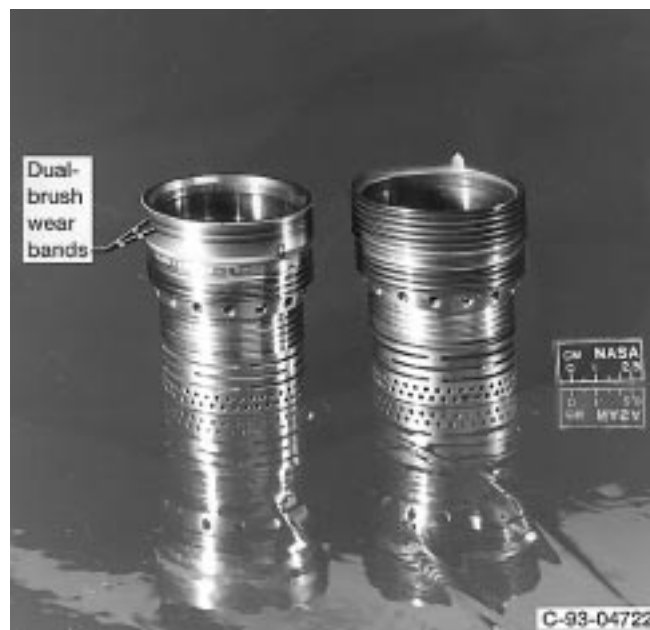
Figure 6.—Compressor discharge seal rotors for labyrinth seal (right) and brush seal (left).

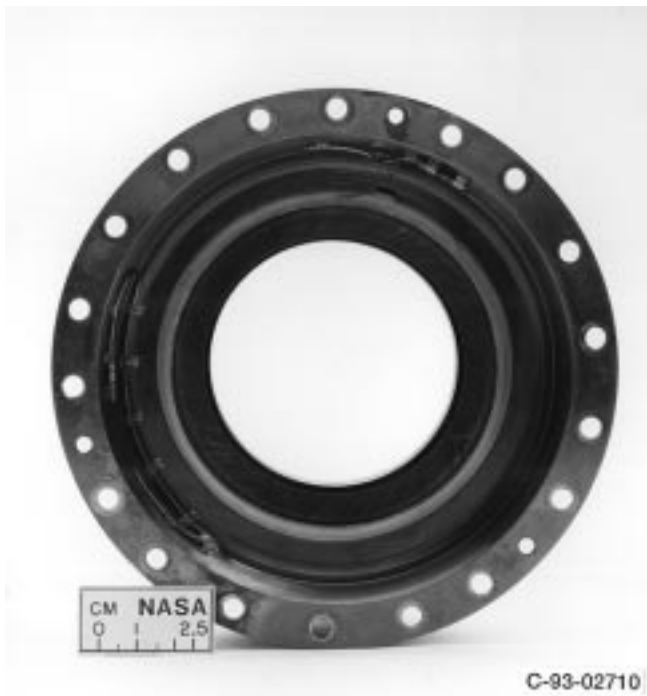
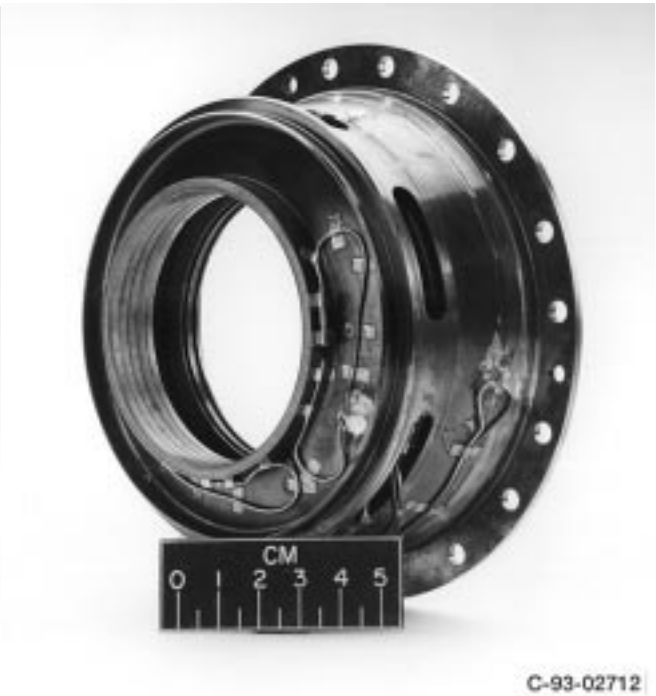
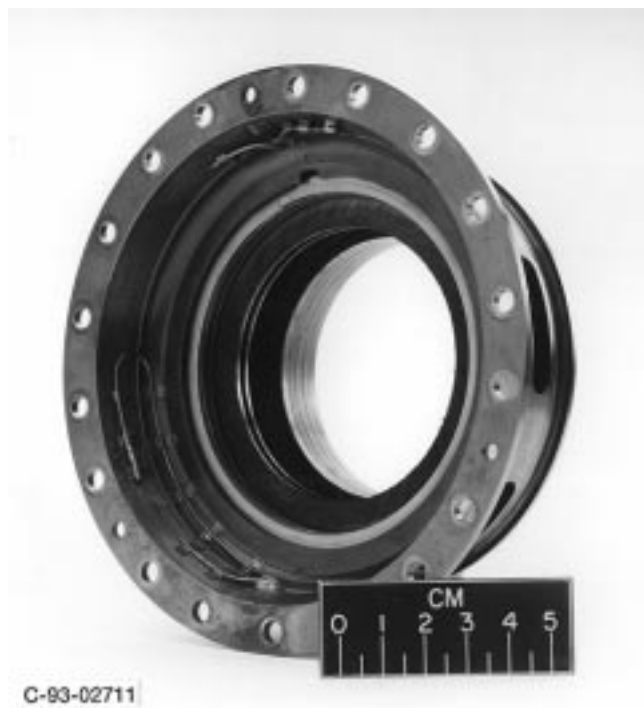
(a) Upstream view.

(b) Downstream view.

(c) Isometric view.

Figure 7.—Dual-brush compressor discharge seal system after testing.

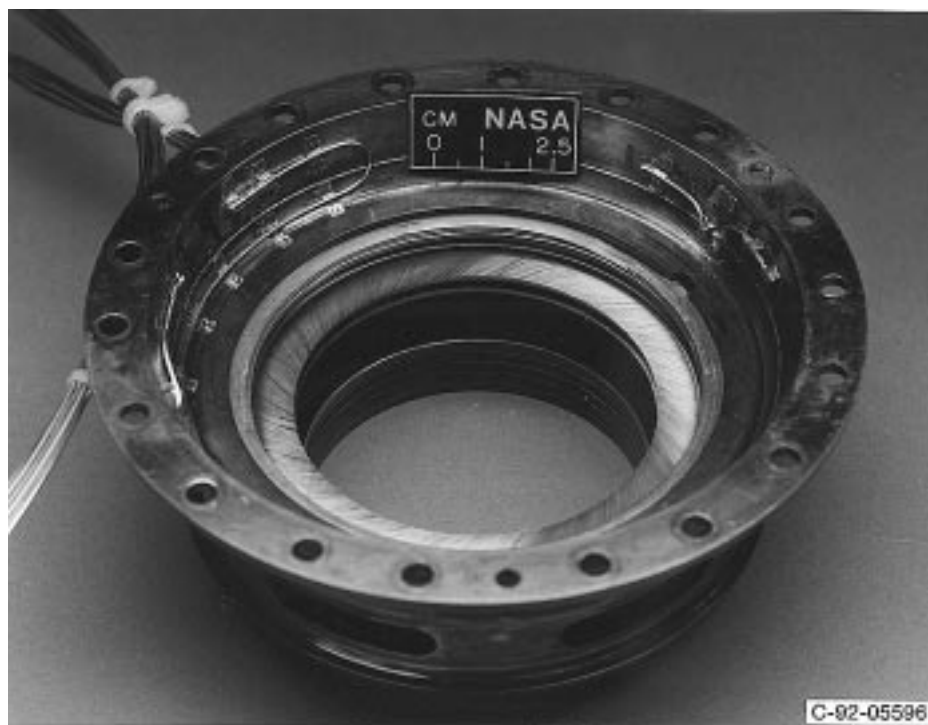
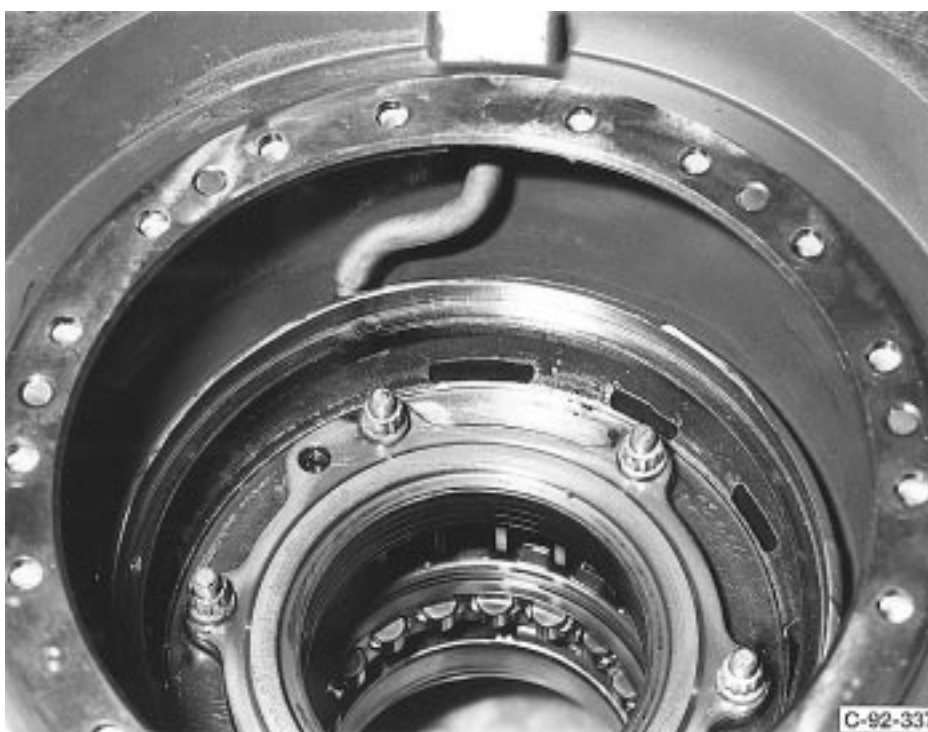
(a) Dual-brush seal.

(b) Seal package cavity and housing.

Figure 8.—Dual-brush seal package installation.

The YT-700 compressor section was first assembled with the labyrinth seal and run as a baseline for comparison. After a test series was completed, the engine was shipped to the Corpus Christi overhaul facility. The compressor discharge seal labyrinth system was removed and the brush package (Fig. 8(a)) inserted into the housing (Fig. 8(b)). The brush seal system was installed without special waxes, which can lead to bristle distortions and irregular bristle voidage. (These waxes hold the bristles off the rotor during installation and readily "burn out" at a low temperature.) The installation was blind; a pencil run about the circumference spread the bristles uniformly, and the shaft rotated as the package was inserted vertically into the engine.

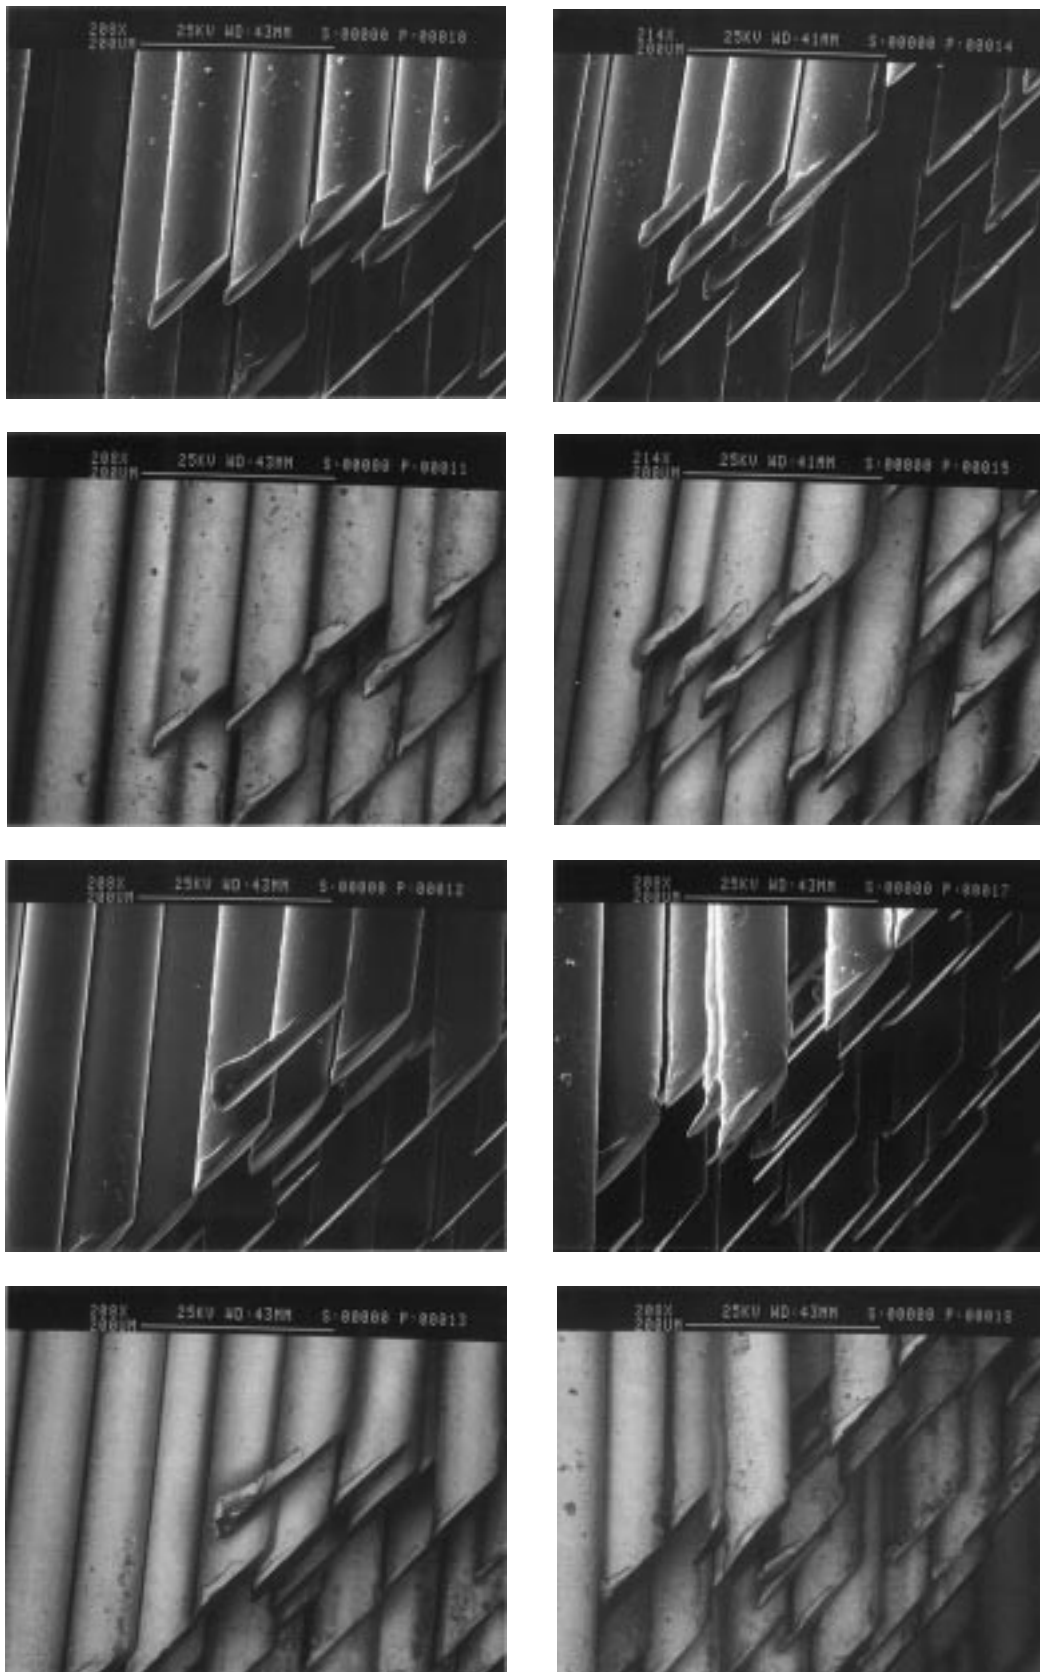
Figure 9.—Closeup views of bristles.

Post-test measurements of the brush and inspection of the bristles revealed a smooth bristle interface with some characteristic shear wear (Fig. 9) but little other visible damage. From an unrecorded visual inspection at 64X prior to test, the bristle tips were sharp, clean, elliptical surfaces. The brush wear patterns (Figs. 10 and 11) were attributed to the engine dynamics although no dynamic tracking instrumentation was available. The patterns are interesting in that they are on the average 15° from the antirotation pin. (The clocking point may be associated with a compressor bearing position or loading point.) The patterns for the upstream seal differed from those for the downstream seal (see also Fig. 4), indicating a differential in pressure drop across each of the seals. It is anticipated that about 40 percent of the total pressure drop across the dual brush occurred across the first brush and 60 percent across the second brush (Flower, 1990, and private communication from R. Flower of Cross Mfg. Ltd.). Such loading resulted in stiffer bristles in the second brush and implies a greater bristle wear. Preload and operational loads are important design life parameters (private communication from Ellen Mayhew of Wright Patterson Air Force Base), but data to quantize these parameters are not available.

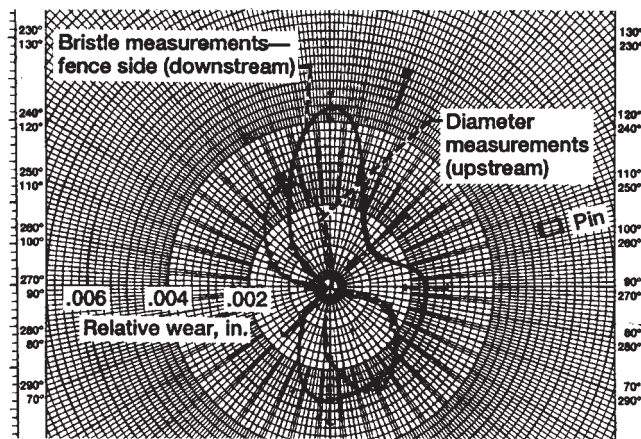
Figure 10.—Wear pattern for compressor discharge seal upstream brush.

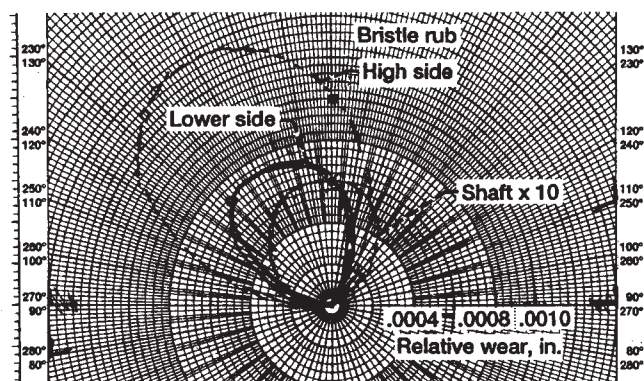
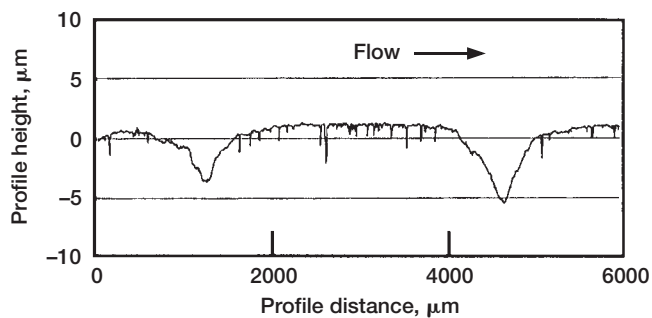
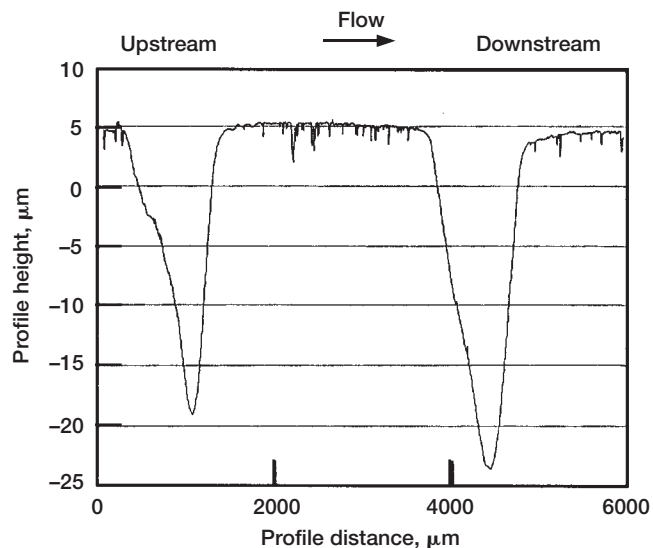
(a) Coating wear pattern.

(b) Discharge seal profile showing slight wear scars.

(c) Discharge seal profile showing deeper wear scars.

Figure 11.—Coating wear pattern and discharge seal profiles for compressor discharge seal rub runner.

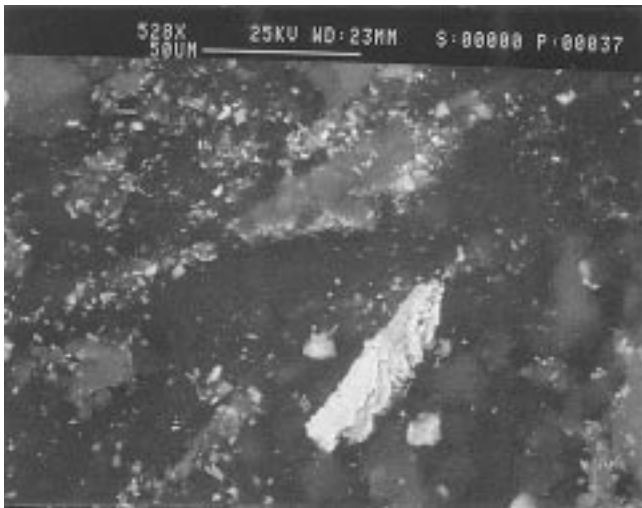
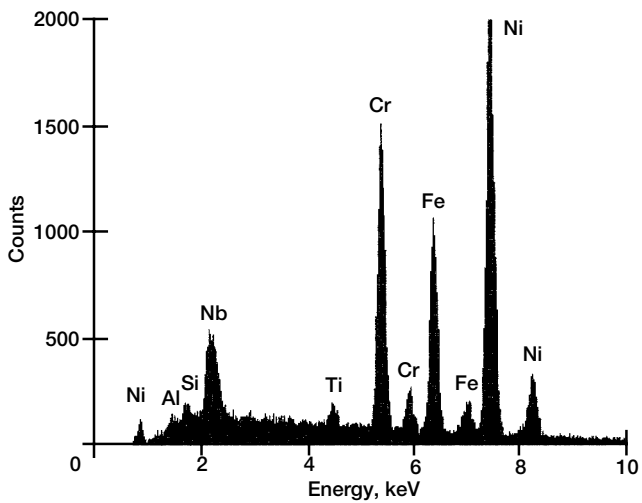
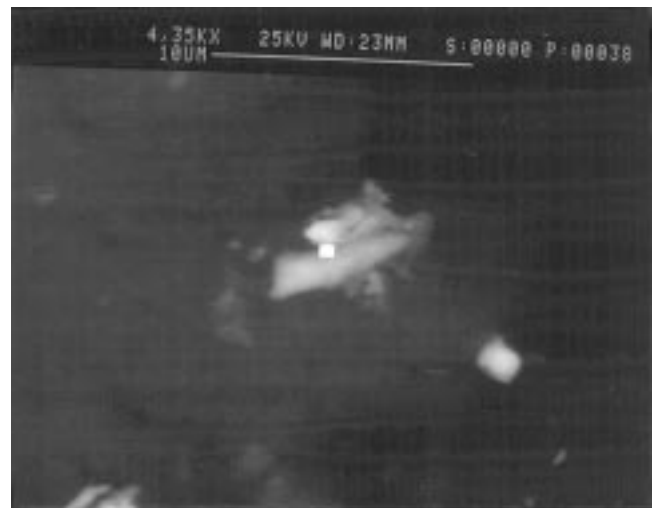
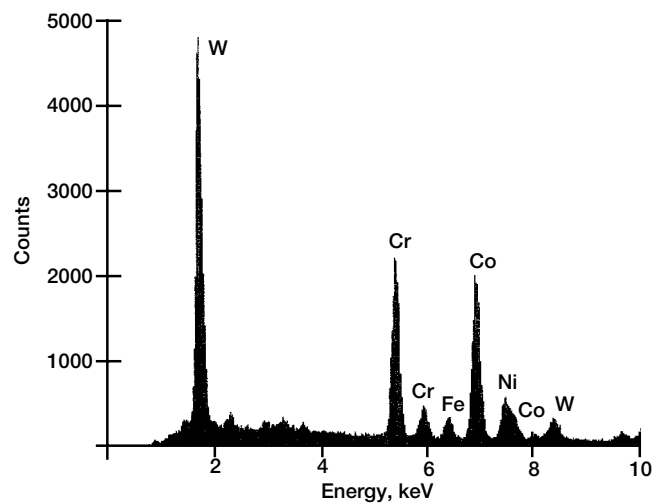
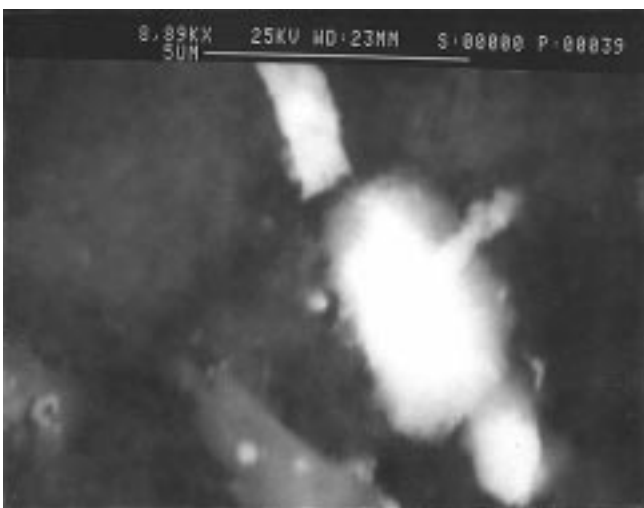
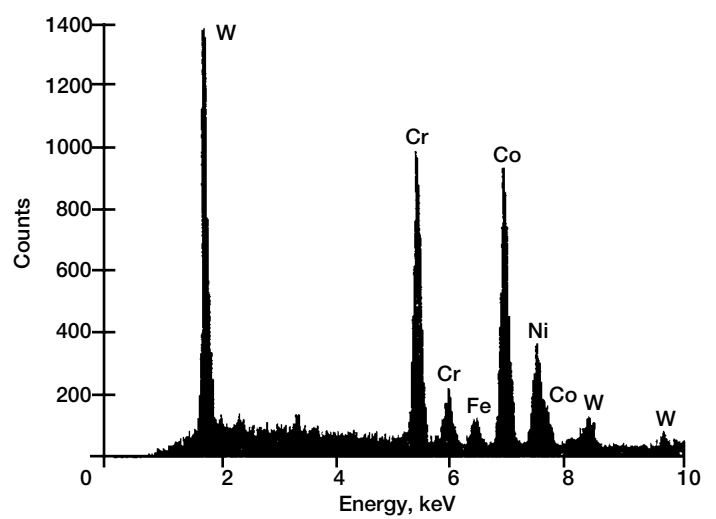
(a) Particle A.

(b) Particle B.

(c) Particle C.

Figure 12.—SEM peaks associated with drain pipe debris.

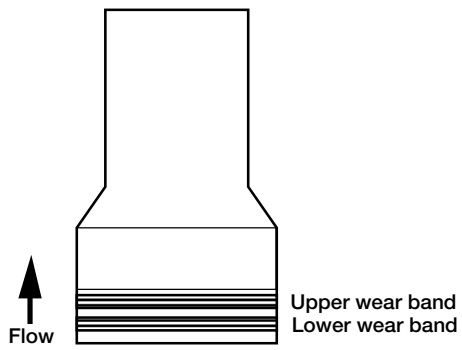
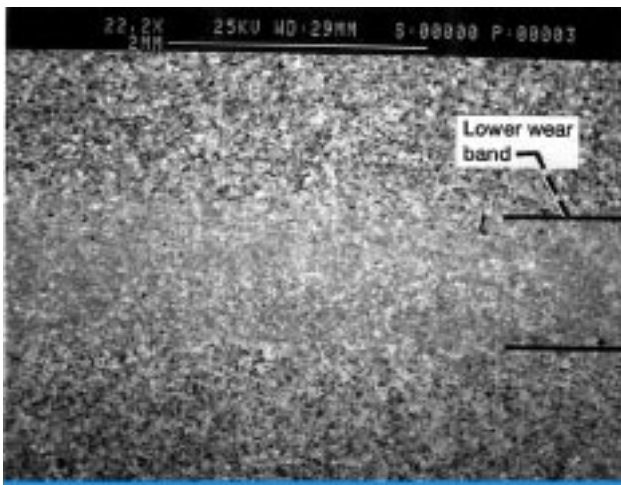
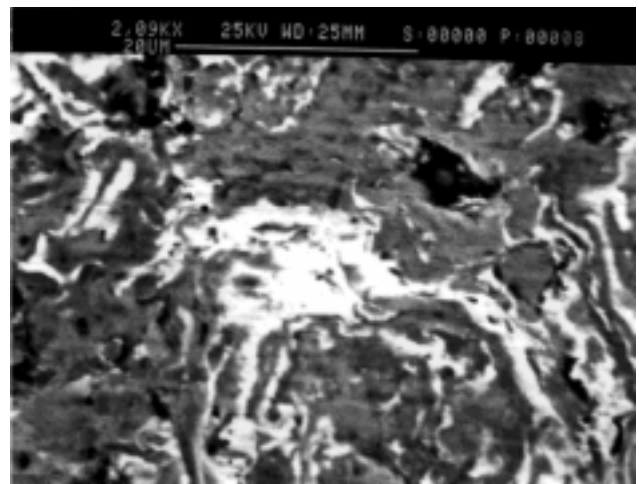
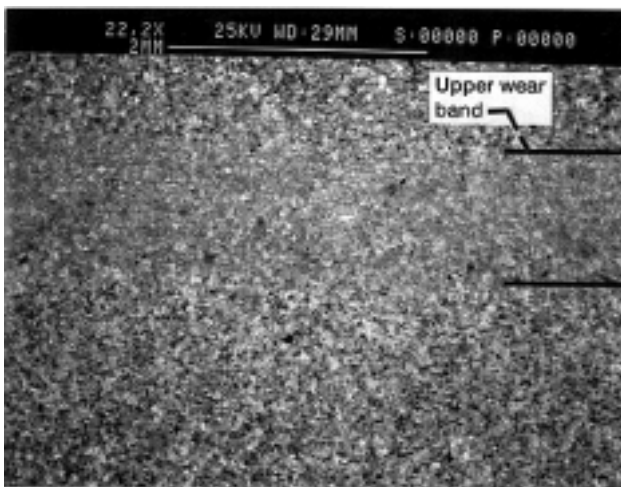
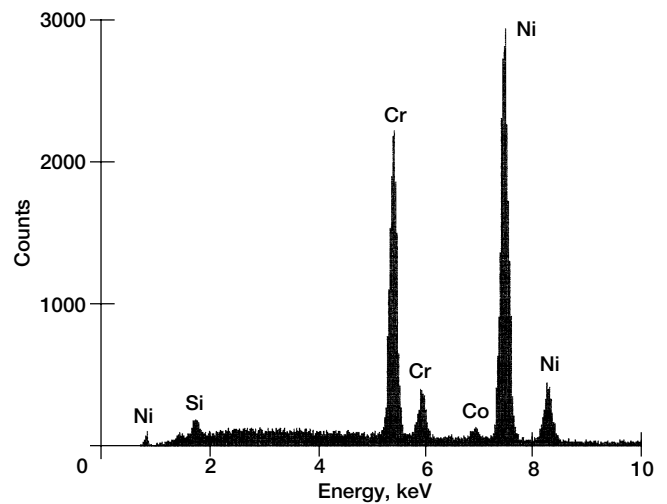
(a) Upstream (lower) wear band.

(b) Downstream (upper) wear band.

(c) Light area in coating matrix between bands.

Figure 13.—SEM peaks associated with chromium-carbide-coated rub runner.

The upstream wear surface of the rub runner is characterized by Fig. 13(a) and the downstream wear surface by Fig. 13(b). The CrC coating is characterized by light and gray areas, and the energy spectrum shows the light areas to be an NiCr composition and the gray areas to be predominantly Cr. The light and gray areas of the matrix or unrubbed material between the bands is illustrated in Figs. 13(c) and (d). Similarly, for the upstream wear band in Figs. 13(e) and (f) and for the downstream wear band in Figs. 13(g) and (h). There appears to be no material transfer from the bristles to the rotor and only minor scarring and polishing.

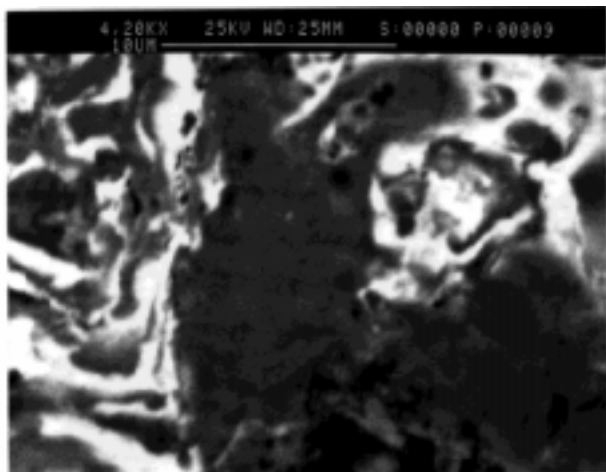
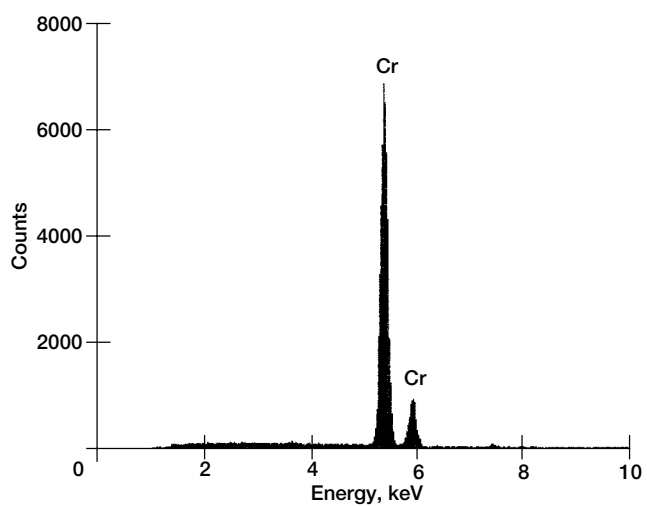
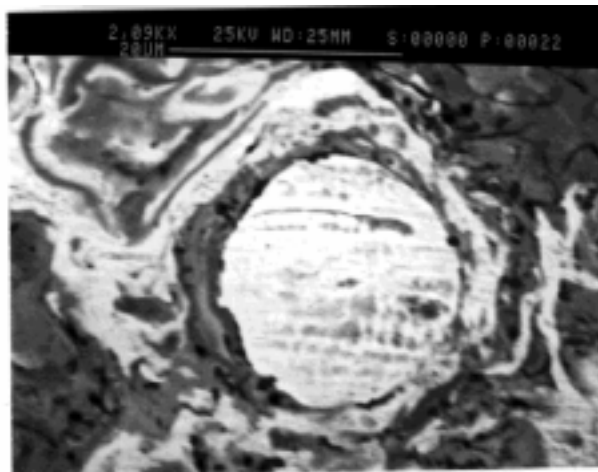
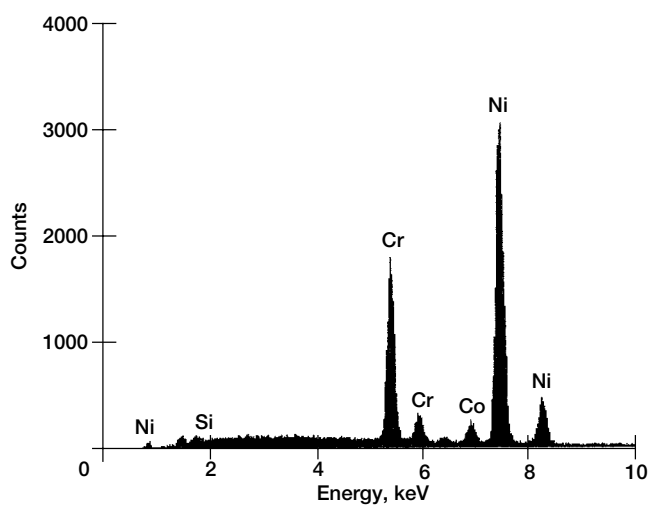
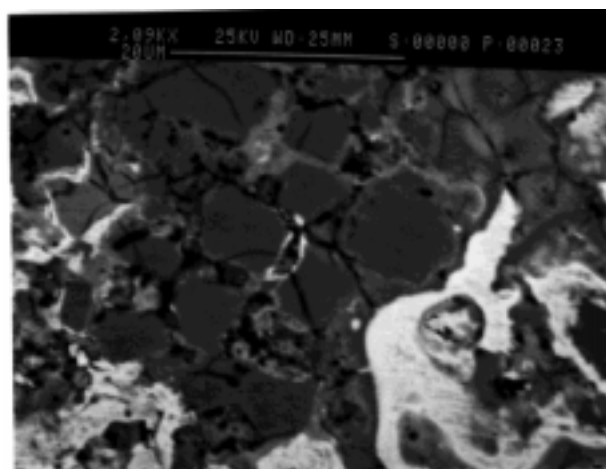
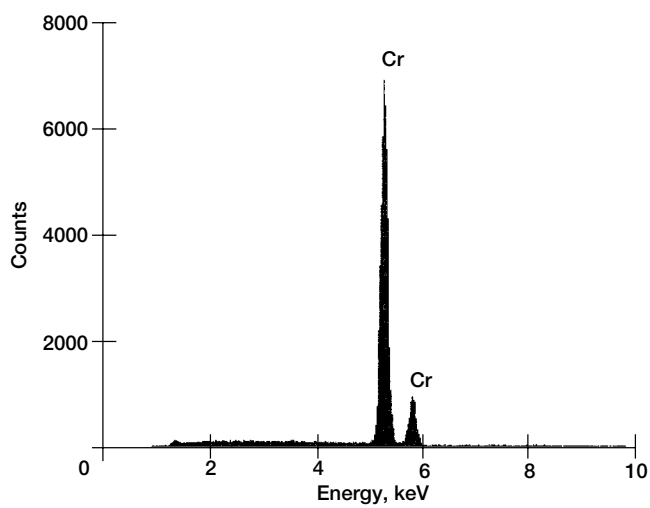
(d) Gray area in coating matrix between bands.

(e) Light area in upstream (lower) wear band.

(f) Gray area in upstream (lower) wear band.

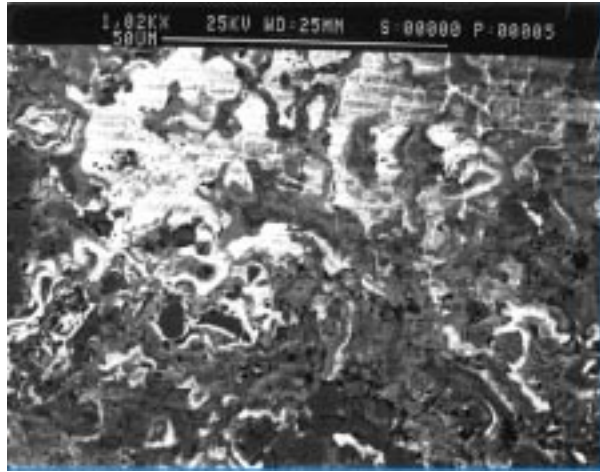
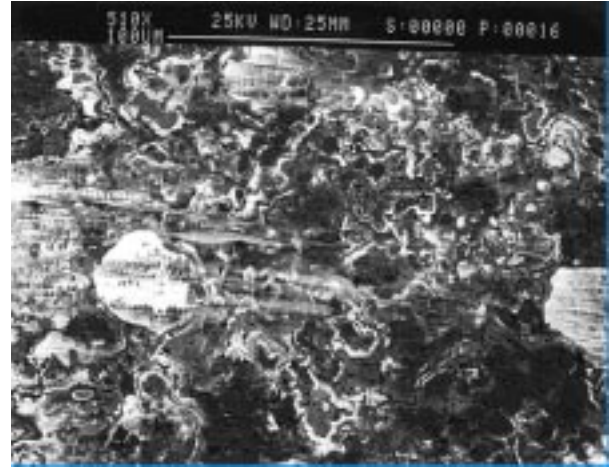
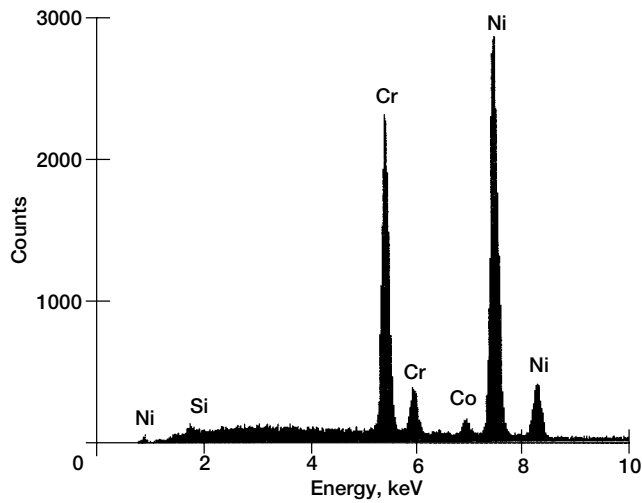
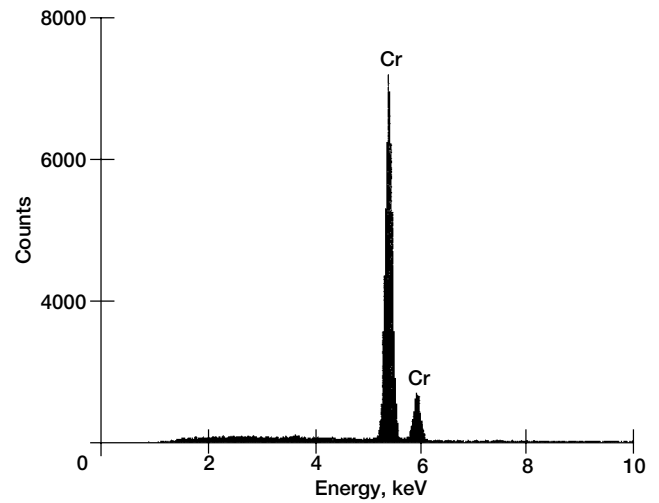
(g) Light area in downstream (upper) wear band.

(h) Gray area in downstream (upper) wear band.

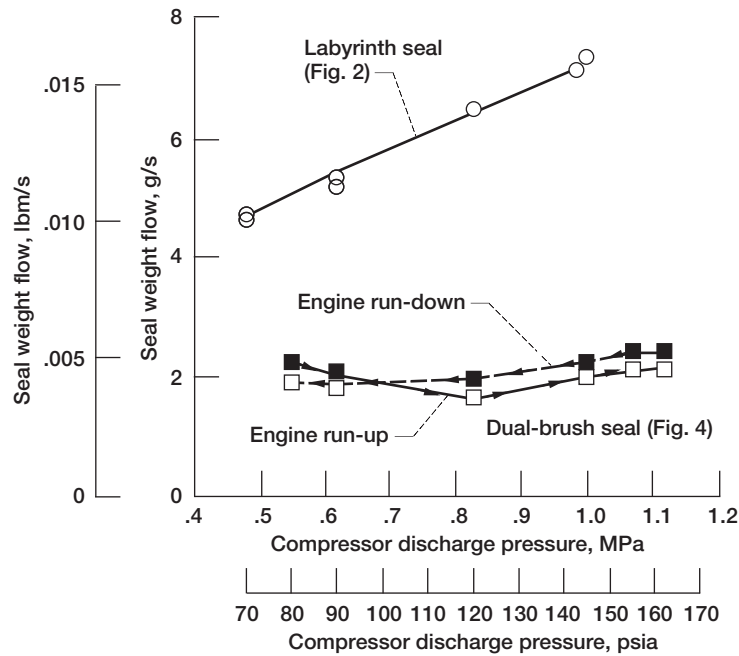
Figure 14.—Seal weight flow as a function of compressor discharge pressure for labyrinth and dual-brush seals.
